ABSTRACT

This document describes the known exceptions to the functional specifications (advisories).

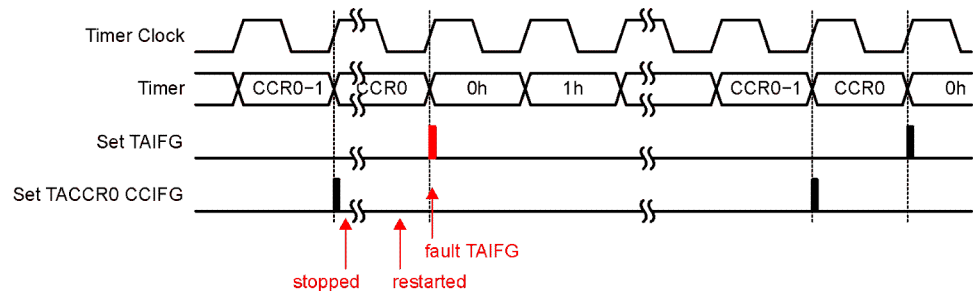
TA21 *TA Module*

Category	Functional
Function	TAIFG Flag is erroneously set after Timer A restarts in Up Mode
Description	In Up Mode, the TAIFG flag should only be set when the timer counts from TACCR0 to zero. However, if the Timer A is stopped at TAR = TACCR0, then cleared (TAR=0) by setting the TACLr bit, and finally restarted in Up Mode, the next rising edge of the TACLK will erroneously set the TAIFG flag.

Workaround	None.
-------------------	-------
