ABSTRACT

This document describes the known exceptions to the functional specifications (advisories).

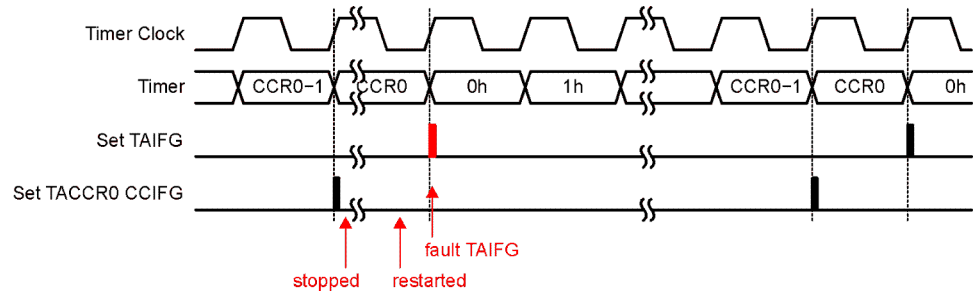
Function TAIFG Flag is erroneously set after Timer A restarts in Up Mode

Description In Up Mode, the TAIFG flag should only be set when the timer counts from TACCR0 to zero. However, if the Timer A is stopped at TAR = TACCR0, then cleared (TAR=0) by setting the TACLRL bit, and finally restarted in Up Mode, the next rising edge of the TACLK will erroneously set the TAIFG flag.

Workaround None.

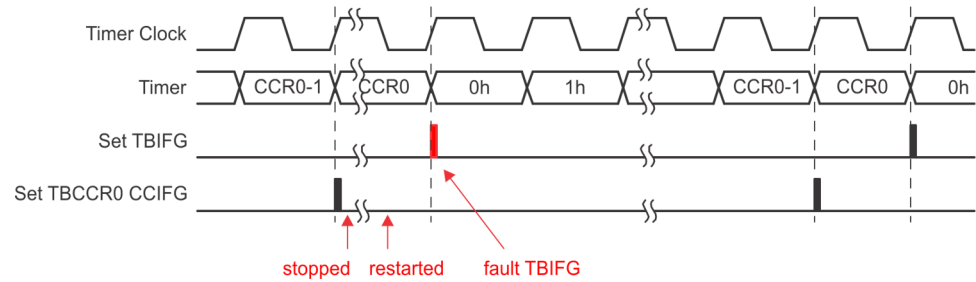
Function TBIFG Flag is erroneously set after Timer B restarts in Up Mode

Description In Up Mode, the TBIFG flag should only be set when the timer resets from TBCCR0 to zero. However, if the Timer B is stopped at TBR = TBCCR0, then cleared (TBR=0) by setting the TBCLR bit, and finally restarted in Up Mode, the next rising edge of the TBCLK will erroneously set the TBIFG flag.

Workaround None.
