## ABSTRACT

This document describes the known exceptions to the functional specifications (advisories).

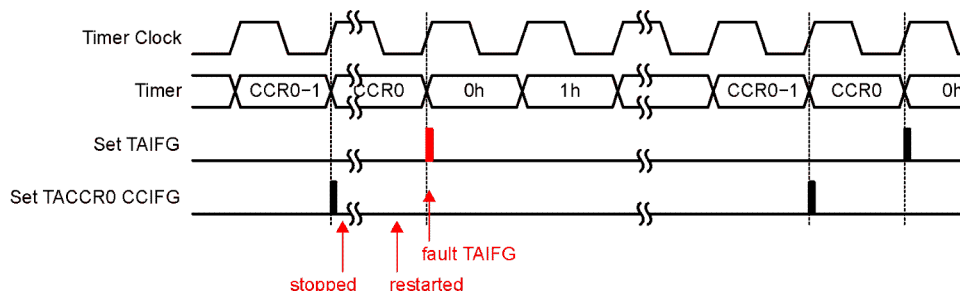
**TA21** *TA Module*

**Function** TAIFG Flag is erroneously set after Timer A restarts in Up Mode

**Description** In Up Mode, the TAIFG flag should only be set when the timer counts from TACCR0 to zero. However, if the Timer A is stopped at TAR = TACCR0, then cleared (TAR=0) by setting the TACLR bit, and finally restarted in Up Mode, the next rising edge of the TACLK will erroneously set the TAIFG flag.

**Workaround** None.
