ABSTRACT

This document describes the known exceptions to the functional specifications (advisories).

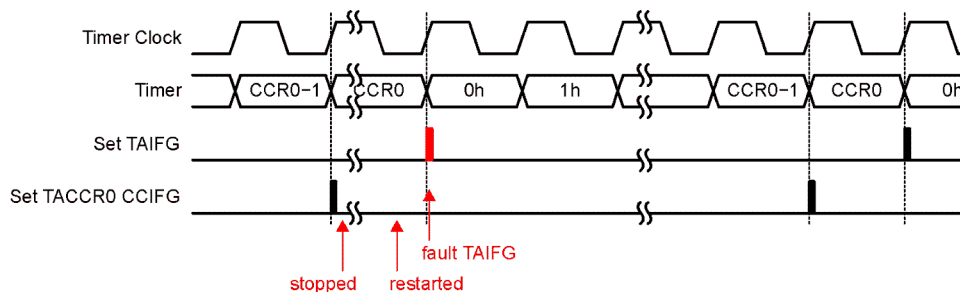
TA21 *TA Module*

Function TAIFG Flag is erroneously set after Timer A restarts in Up Mode

Description In Up Mode, the TAIFG flag should only be set when the timer counts from TACCR0 to zero. However, if the Timer A is stopped at TAR = TACCR0, then cleared (TAR=0) by setting the TACLr bit, and finally restarted in Up Mode, the next rising edge of the TACLK will erroneously set the TAIFG flag.

Workaround None.

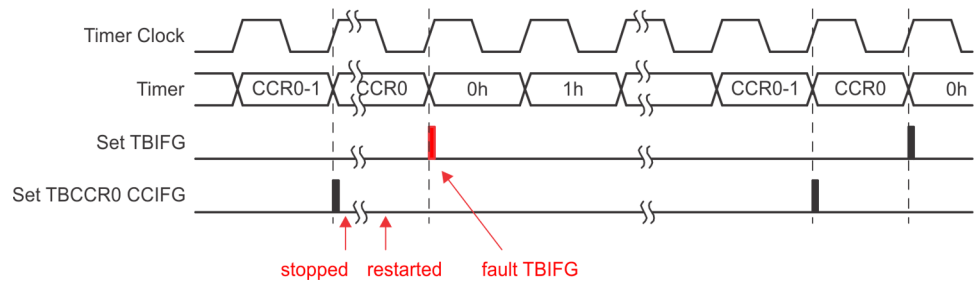
TB24 *TB Module*

Function TBIFG Flag is erroneously set after Timer B restarts in Up Mode

Description In Up Mode, the TBIFG flag should only be set when the timer resets from TBCCR0 to zero. However, if the Timer B is stopped at TBR = TBCCR0, then cleared (TBR=0) by setting the TBCLR bit, and finally restarted in Up Mode, the next rising edge of the TBCLK will erroneously set the TBIFG flag.

Workaround None.
