Errata
MSP430F47193 Microcontroller

ABSTRACT

This document describes the known exceptions to the functional specifications (advisories).

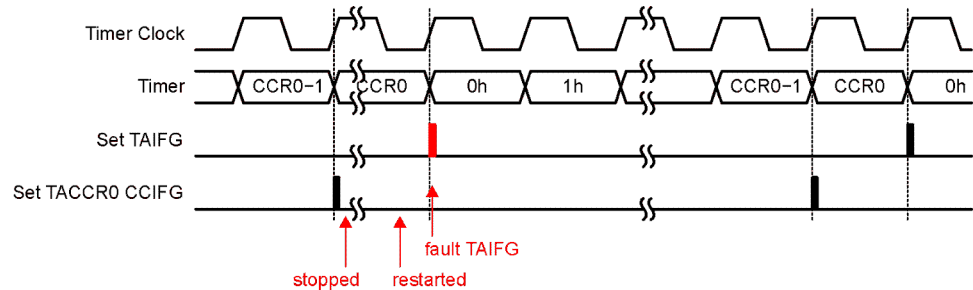
TA21 *TA Module*

Function TAIFG Flag is erroneously set after Timer A restarts in Up Mode

Description In Up Mode, the TAIFG flag should only be set when the timer counts from TACCR0 to zero. However, if the Timer A is stopped at TAR = TACCR0, then cleared (TAR=0) by setting the TACLr bit, and finally restarted in Up Mode, the next rising edge of the TACLK will erroneously set the TAIFG flag.

Workaround None.
