Errata  
**MSP430F5519 Microcontroller**

This document describes the known exceptions to the functional specifications (advisories).

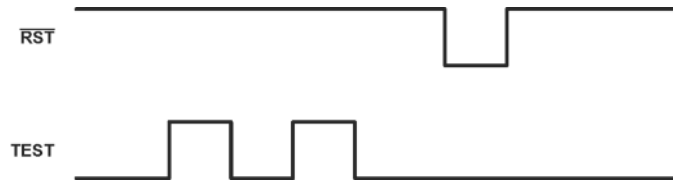
The methods used to exit the BSL per MSP430 Programming Via the Bootstrap Loader ([SLAU319](#)) are invalid.

- Workaround** To exit the BSL one of the following methods must be used.
- A Power cycle
- or
- Toggle the TEST pin twice when nRST is high and after 50us pull nRST low.

Note: This toggling of TEST pins is not subject to timing constraints. The appropriate level transitions on TEST pin, followed by a RST pulse after 50us, are sufficient to trigger an exit from BSL mode.
