ABSTRACT

This document describes the known exceptions to the functional specifications (advisories).

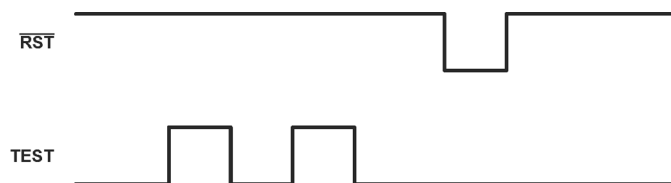
JTAG20	JTAG Module
Category	Software in ROM
Function	BSL does not exit to application code
Description	The methods used to exit the BSL per MSP430 Programming Via the Bootstrap Loader (SLAU319) are invalid.
Workaround	To exit the BSL one of the following methods must be used. <ul style="list-style-type: none"> - A Power cycle or <ul style="list-style-type: none"> - Toggle the TEST pin twice when nRST is high and after 50us pull nRST low.

Note: This toggling of TEST pins is not subject to timing constraints. The appropriate level transitions on TEST pin, followed by a RST pulse after 50us, are sufficient to trigger an exit from BSL mode.
