ABSTRACT

This document describes the known exceptions to the functional specifications (advisories).

6 Advisory Descriptions

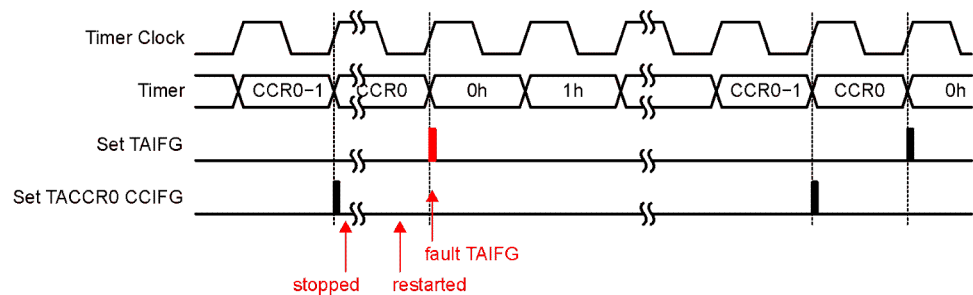
TA21 *TA Module*

Function TAIFG Flag is erroneously set after Timer A restarts in Up Mode

Description In Up Mode, the TAIFG flag should only be set when the timer counts from TACCR0 to zero. However, if the Timer A is stopped at TAR = TACCR0, then cleared (TAR=0) by setting the TACLR bit, and finally restarted in Up Mode, the next rising edge of the TACLK will erroneously set the TAIFG flag.

Workaround None.
