Errata
MSP430G2332 Microcontroller

This document describes the known exceptions to the functional specifications (advisories).

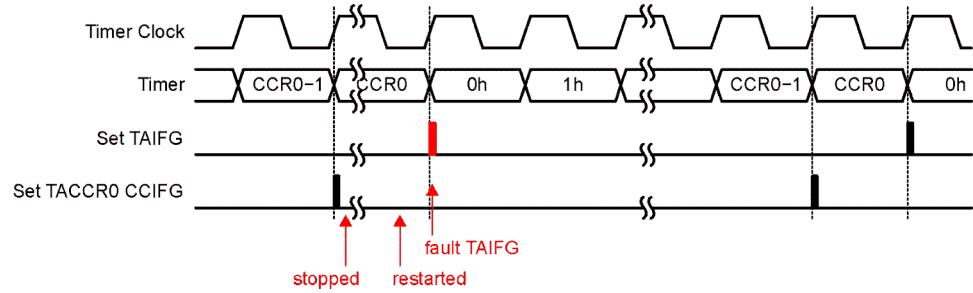
Workaround	Switch capture/compare mode to capture mode before the CCRx register increment. Switch back to compare mode afterwards.
TA16	TA Module
Category	Functional
Function	First increment of TAR erroneous when IDx > 00
Description	The first increment of TAR after any timer clear event (POR/TACLR) happens immediately following the first positive edge of the selected clock source (INCLK, SMCLK, ACLK or TACLK). This is independent of the clock input divider settings (ID0, ID1). All following TAR increments are performed correctly with the selected IDx settings.
Workaround	None
TA21	TA Module
Category	Functional
Function	TAIFG Flag is erroneously set after Timer A restarts in Up Mode
Description	In Up Mode, the TAIFG flag should only be set when the timer counts from TACCR0 to zero. However, if the Timer A is stopped at TAR = TACCR0, then cleared (TAR=0) by setting the TACLR bit, and finally restarted in Up Mode, the next rising edge of the TACLK will erroneously set the TAIFG flag.

Workaround None.
