AM1810 ARM Microprocessor Silicon Revisions 2.3, 2.1 and 2.0

Silicon Errata

Literature Number: SPRZ339H
November 2010–Revised September 2014

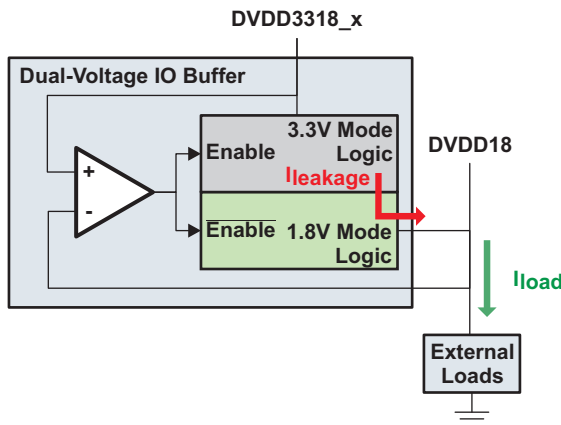
Figure 6. Error State of the IO buffer during Zone G

As DVDD3318_x exceeds DVDD18+V_T, some of the circuitry across the boundary of the two voltage domains will turn on and causes a leakage current (in red) to flow between the two voltage domains. This current pulls up the DVDD18 supply unless the power source providing that supply can oppose it or unless the load current is strong enough to counteract it.

If DVDD18 continues to rise as DVDD3318_x ramps, the comparator never sees enough difference between the two supplies to switch to 3.3V mode.

- (a) Maintain sufficient bulk capacitance on the DVDD18 supply such that the charging current for these capacitors provides all or part of the required >140 mA. Bulk capacitance in this context means the total capacitance seen by the DVDD18 supply (filter capacitors, bypass capacitors, etc.). Capacitor charging current is defined as $I = C \cdot (dV/dt)$. So the ramp rate of the DVDD3318_x supply and the total bulk capacitance on the DVDD18 supply can be used to calculate the current produced. This solution provides additional power supply filtering and little current leakage after the supplies are ramped (depending on the type of capacitors used).

2. Choose a regulator for the DVDD18 supply (or grouped 1.8V supplies) that is capable of actively regulating voltage up and down. Many high-efficiency switching regulators switch current into the load only when the voltage needs to be raised and rely on the load to pulldown the current. In this error condition, a regulator of this type will not be able to compensate for the leakage current described above. Synchronous buck regulators use external inductance to pulldown the regulated voltage when necessary.
