AM1802 ARM Microprocessor Silicon Revisions 2.3, 2.1 and 2.0

Silicon Errata

Literature Number: SPRZ340H
November 2010–Revised September 2014

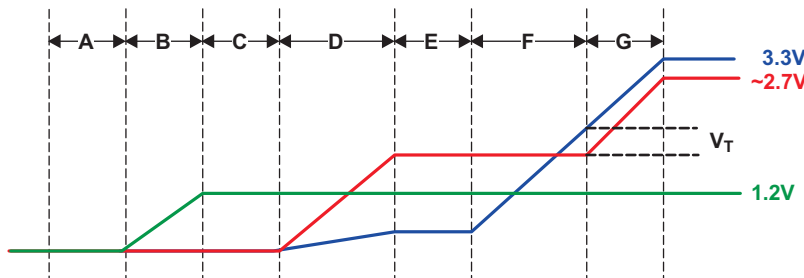
Figure 4. Faulty power-supply ramp

The behavior is the same until zone G. When the DVDD3318_x supply exceeds DVDD18 by a transistor V_T, the DVDD18 supply begins to be pulled up by the DVDD3318_x supply and follows the DVDD3318_x supply by DVDD3318_x - V_T. Since the DVDD18 supply is often connected to other 1.8V supplies in the design, these other supplies can be pulled up also.

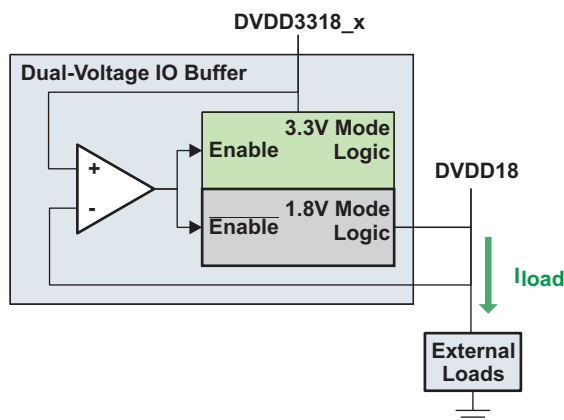
Recovered State of the IO buffer during Zone G:

If the load current is high enough or the DVDD18 power supply can oppose the leakage current, then the DVDD18 voltage stays low enough for:

- the comparator to recognize 3.3V mode
- the 1.8V mode logic is turned off
- the leakage stops

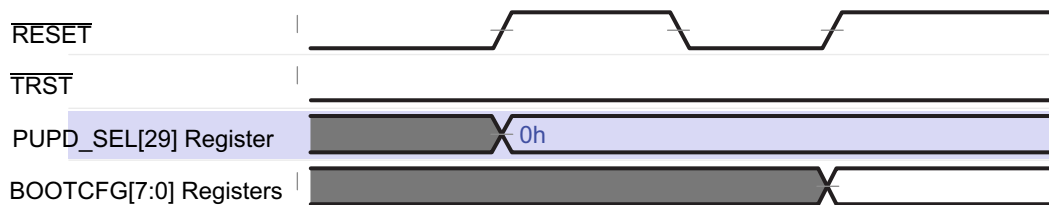
Initialization of PUPD_SEL[29] and BOOTCFG[7:0] Registers with Weak or No External Pull Resistors on BOOT[7:0] Pins

Internal pullups being enabled on the BOOT[7:0] pins may result in boot failures. If weak external pulldown resistors are used on the PCB to select the boot mode, they may not be able to overpower the internal pullups. This can result in the wrong boot mode being latched in the BOOTCFG[7:0] register when coming out of Reset.

Once the device is out of Reset, the PUPD_SEL[29] register is initialized, and the internal pulldown resistors for the BOOT[7:0] pins are all enabled. Issuing a second Power-On Reset ($\overline{\text{POR}}$) results in the intended boot mode being latched, since the pins are internally pulled down as expected.
