TMS320F2806x Real-Time MCUs Silicon Errata

Silicon Revisions B, A, 0

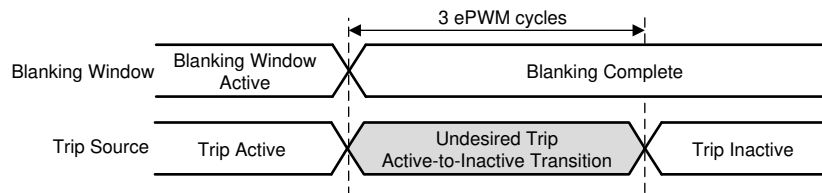
Figure 3-4. Undesired Trip Event and Blanking Window Expiration

Details The blanking window is typically used to mask any PWM trip events during transitions which would be false trips to the system. If an ePWM trip event remains active for less than three ePWM clocks after the end of the blanking window cycles, there can be an undesired glitch at the ePWM output.

Figure 3-4 illustrates the time period which could result in an undesired ePWM output.
