ABSTRACT

This document describes the known exceptions to the functional specifications (advisories).

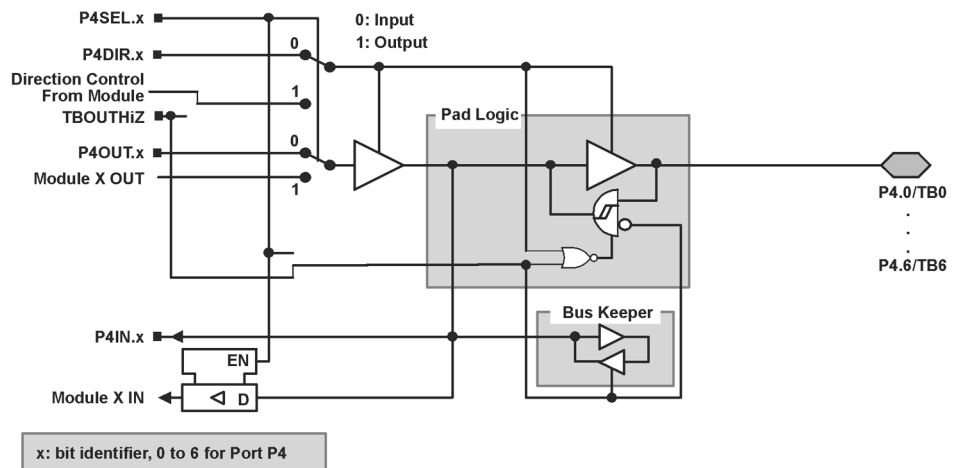
Port Realization With TB3 Bug

TB3	<i>TB Module</i>
Category	Functional
Function	Timer_B Port is switched to 3-state independent of selected function
Description	Incorrect 3-state function of Ports P4.0/TB0 through P4.6/TB6 (TBoutHiZ control). If TBoutHiZ is set to high, all ports P4.0/TB0 through P4.6/TB6 are set to 3-state, independent of the P4SEL.x control signals. This means a port P4.x is switched to 3-state with TBoutHiZ, even if it is not selected for Timer_B function. In addition, the ports P4.0/TB0 through P4.6/TB6 are switched to 3-state with TBoutHiZ, even if the port direction (direction control from module) is set to input. This is in accordance with the specification description but, nevertheless, is an unexpected behavior.
Workaround	No workaround. Port function as specified
