## ABSTRACT

This document describes the known exceptions to the functional specifications (advisories).

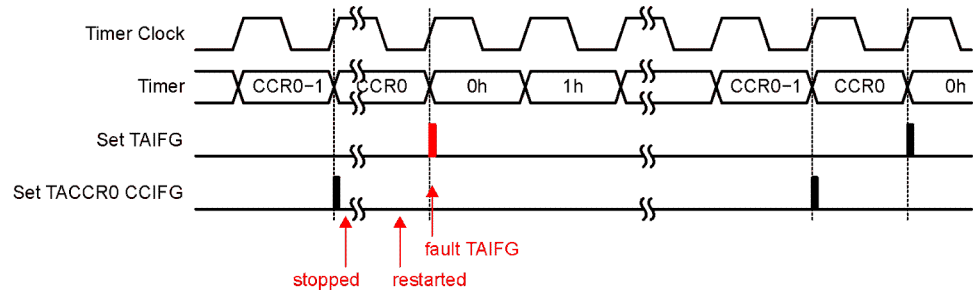
**TA21** *TA Module*

**Function** TAIFG Flag is erroneously set after Timer A restarts in Up Mode

**Description** In Up Mode, the TAIFG flag should only be set when the timer counts from TACCR0 to zero. However, if the Timer A is stopped at TAR = TACCR0, then cleared (TAR=0) by setting the TACLRL bit, and finally restarted in Up Mode, the next rising edge of the TACLK will erroneously set the TAIFG flag.

**Workaround** None.
