## ABSTRACT

This document describes the known exceptions to the functional specifications (advisories).

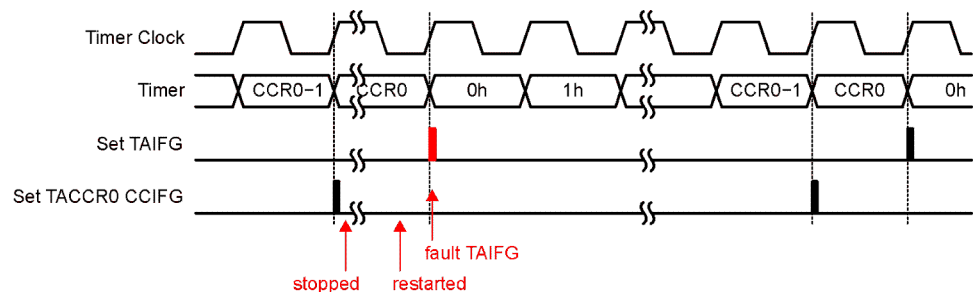
**TA21** *TA Module*

**Function** TAIFG Flag is erroneously set after Timer A restarts in Up Mode

**Description** In Up Mode, the TAIFG flag should only be set when the timer counts from TACCR0 to zero. However, if the Timer A is stopped at TAR = TACCR0, then cleared (TAR=0) by setting the TACLr bit, and finally restarted in Up Mode, the next rising edge of the TACLK will erroneously set the TAIFG flag.

**Workaround** None.

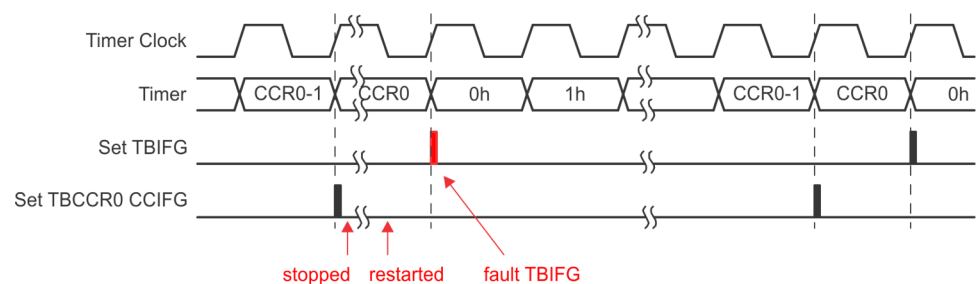
**TB24**
**TB Module**
**Category**

TBIFG Flag is erroneously set after Timer B restarts in Up Mode

In Up Mode, the TBIFG flag should only be set when the timer resets from TBCCR0 to zero. However, if the Timer B is stopped at  $TBR = TBCCR0$ , then cleared ( $TBR=0$ ) by setting the TBCLR bit, and finally restarted in Up Mode, the next rising edge of the TBCLK will erroneously set the TBIFG flag.

None.
