# **TMS320C6670**

*Multicore Fixed and Floating-Point System-on-Chip*

## **Silicon Errata**

Literature Number: SPRZ332F  
May 2014

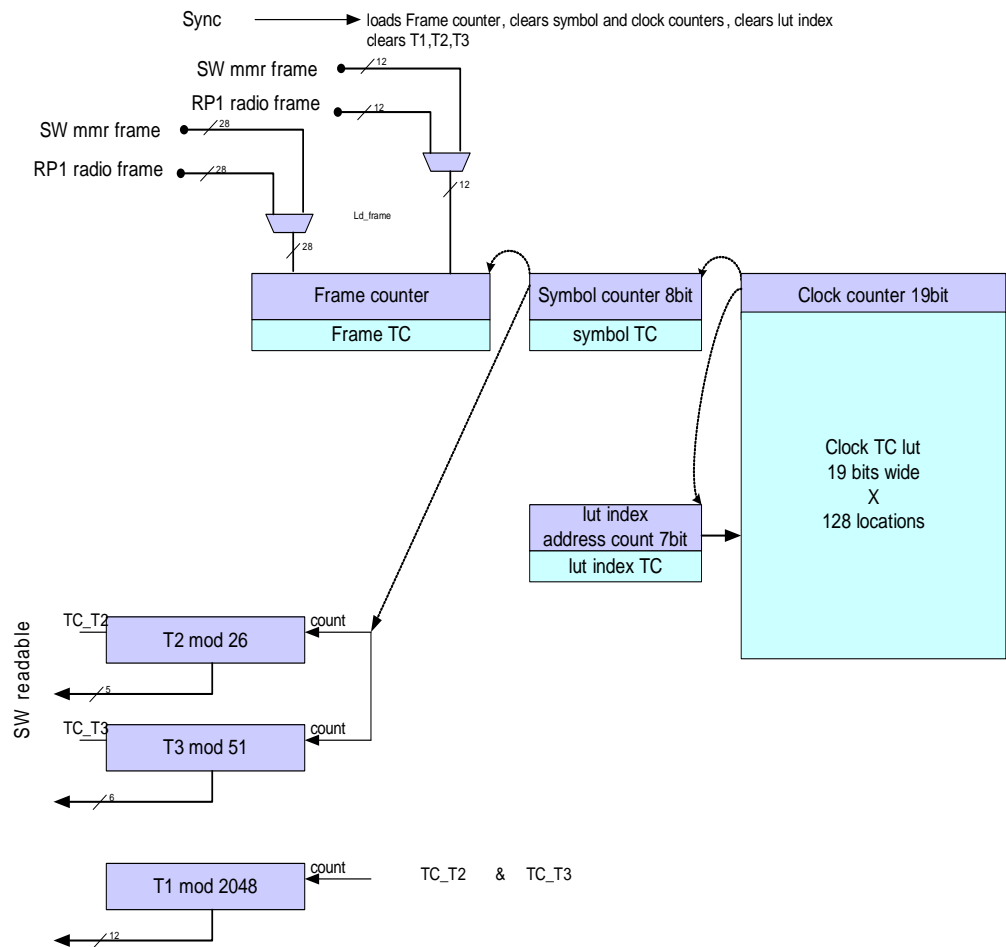
**Figure 4 Radio Timer with GSM Time**

However, one architecture problem was found while running the GSM system level test. The radio timer frame counter is programmed to count 60 ms, which is 13 GSM frame lengths. This configuration had to be done, because 60 ms is the first  $n \times 10$  ms frame boundary which aligns to the OBSAI/CPRI PHY frame boundary (10 ms). In this case, the radio timer should have 104 as a symbol terminal count because there are a total of 104 GSM time slots within 60 ms. In this case, the radio timer should have 104 as a symbol terminal count because there are 104 GSM time slots within 60 ms. With a 104 symbol terminal count, there are not enough calculations to show the correct values on the T1, T2, and T3 counters.

**Workaround:** An additional AT event can be assigned to generate an event every GSM slot time. The ISR may check mod 8 count per visit and the T2 and T3 count array can be updated manually when the mod 8 count wraps around. TC\_T1 count can be calculated by a bitwise AND operation between TC\_T2 and TC\_T3.

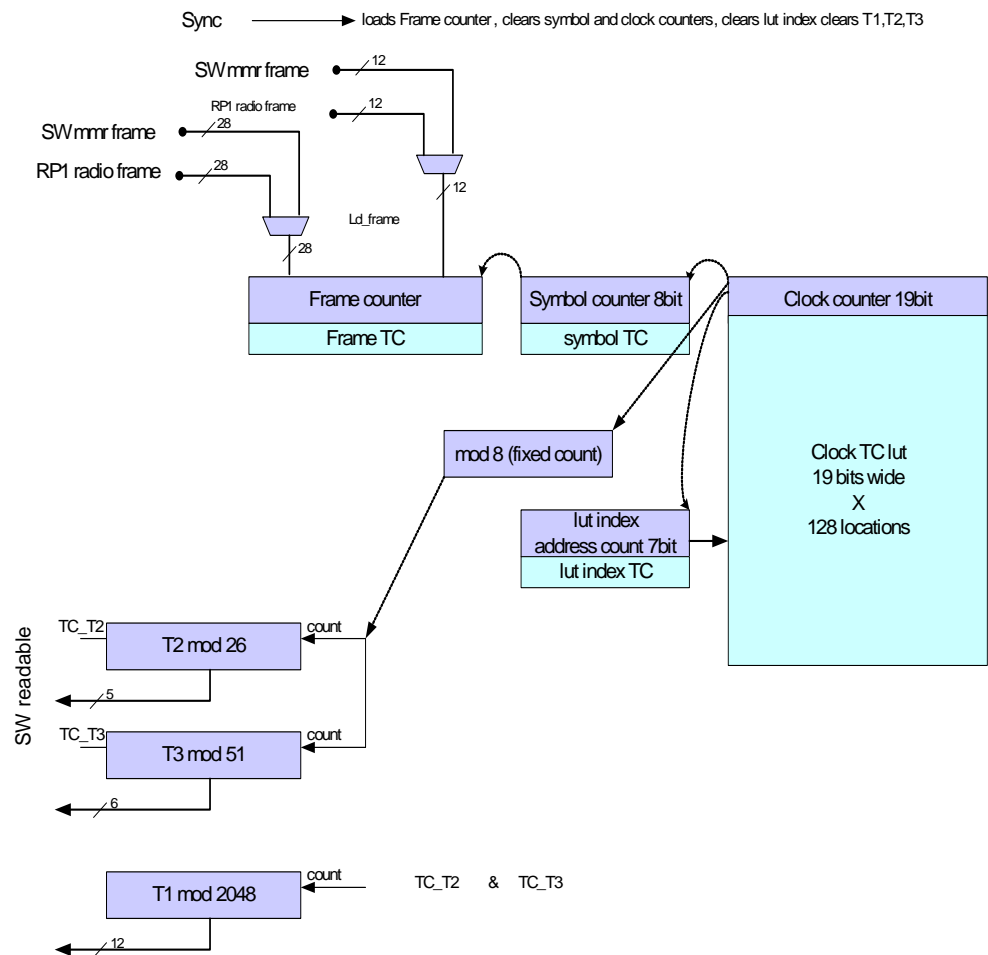
**Figure 5** GSM T Counter Design Change

To fix this problem, it is necessary to add a mod 8 counter that increases its value every radio symbol time. When the mod 8 count wraps around, the T1, T2, and T3 counters are incremented by 1. As a safety feature, the mod 8 counter resets to 0 every time the radio frame count is incremented by 1. The T1, T2, and T3 counters reset only when the radio timer is fully re-synchronized. Figure 5 shows how the current GSM T counter design should be changed.

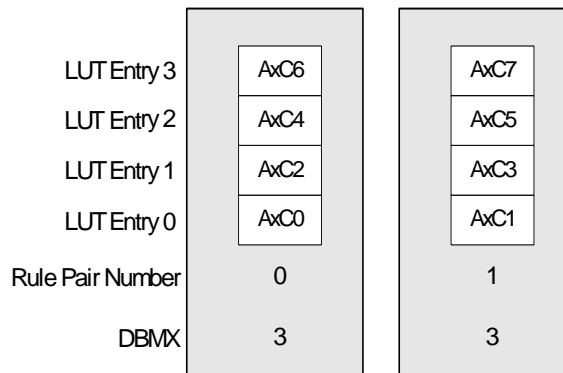
**Figure 6** OBSAI Message Frame Ordering for Two Rule Pairs

For OBSAI (Open Base Station Architecture Initiative), the protocol encoder supports two kinds of transmission rules—modulo and DBRM—to interleave multiple channel data into one link. There are 64 modulo rules and 64 DBMR rules. When using both rules together they share the same index numbers. If the user sets only one modulo rule and DBMR for a specific link, it does not cause any lookup table confusion and perfectly supports multiple numbers of entries (channels) with the correct interleaving. However, if the user assigns multiple numbers of rules with multiple entries (channels), the operation does not work correctly. The lookup table index always resets to 0 after visiting the rules except for the last rule pair.

Expected framing order: **AxC0**, AxC1, **AxC2**, AxC3, **AxC4**, AxC5, **AxC6**, AxC7

Framing order of current hardware **AxC0**, AxC1, **AxC0**, AxC3, **AxC0**, AxC5, **AxC0**, AxC7

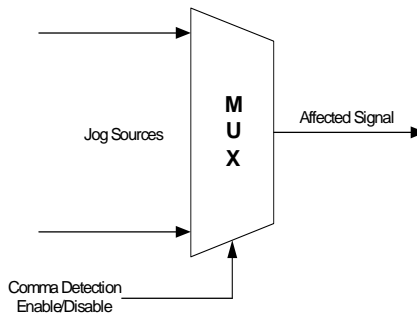
**Figure 7 Affected Signal**

The jog request (mux output), which is shown as Affected Signal in Figure 7, is fed to a synchronizer located elsewhere in the SerDes. This signal can glitch while disabling comma detection. Depending on the PVT and line frequency, this glitch can be misinterpreted as a spurious jog request, which can corrupt the alignment. PVT dependency is such that not all devices will exhibit the issue.

All the six lanes are affected with this issue. AIF2 has two SerDes modules inside. One module has lane0 to lane3 and the other has lane4 and lane5. The glitch is dependent on layout differences between these two macros so it is possible that only some of the six lanes will show this issue and some will not.

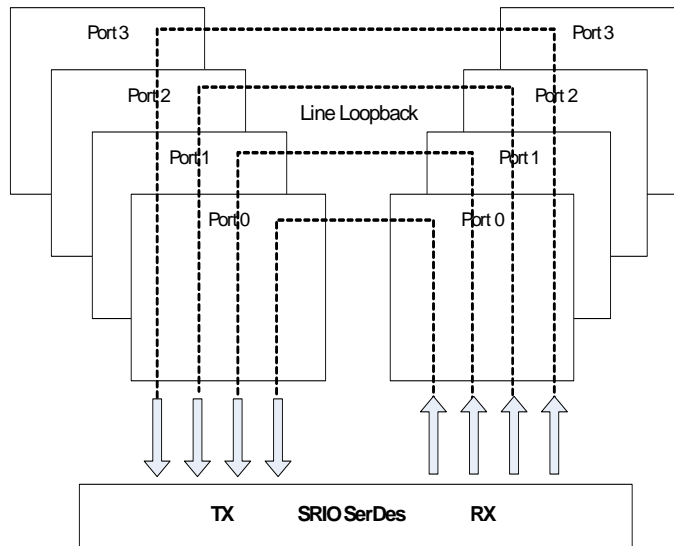
**Figure 8 SRIO SerDes in Loopback Mode**

The port does not provide any clock compensation when line loopback is enabled. The transmit clock must be externally synchronized with the receive clock. There is only a small FIFO that can compensate for PLL jitter or wander. Hence, correct operation of line loopback requires that the link partners use the same reference clock for the SRIO physical layer, in order to avoid overruns or underruns due to clock frequency mismatch between the link partners. As a result, line loopback mode is generally restricted to validation and qualification of board signal integrity in a lab environment.

When line loopback is enabled on one or more SRIO ports, any valid 10b code group that decodes to an illegal control character as defined by the RapidIO Specification (Revision 2.1) and whose most significant bit is 0, will be corrupted on transmission. This issue can be summarized as follows:

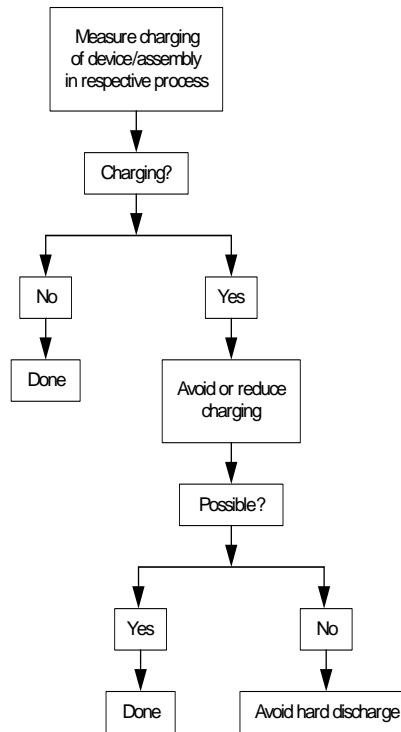
**Figure 9 Basic Flow for Analyzing CDM Risk**

Due to the sensitive nature of the SerDes high-speed pins, exceeding component ESD CDM stress pulses of 150 V on the functional pins listed below may cause permanent changes to the output swing and the de-emphasis behavior associated with these pins.

**Workaround:** While there is no strict workaround for this issue, there are several ways to analyze the risk with regards to CDM. [Figure 9](#) shows the basic flow for analyzing this risk:

Using generally accepted good practices during the assembly process can help to minimize the likelihood of a hard discharge. These practices include:

- The use of an ionizer near the PCB before, during, and after placement of parts
- The use of grounded, conductive/dissipative suction cups when using pick-and-place machines
- The use of dissipative materials for downholder pins and/or plastic covers as well as two-stage pogo-pins while performing in-circuit-test.

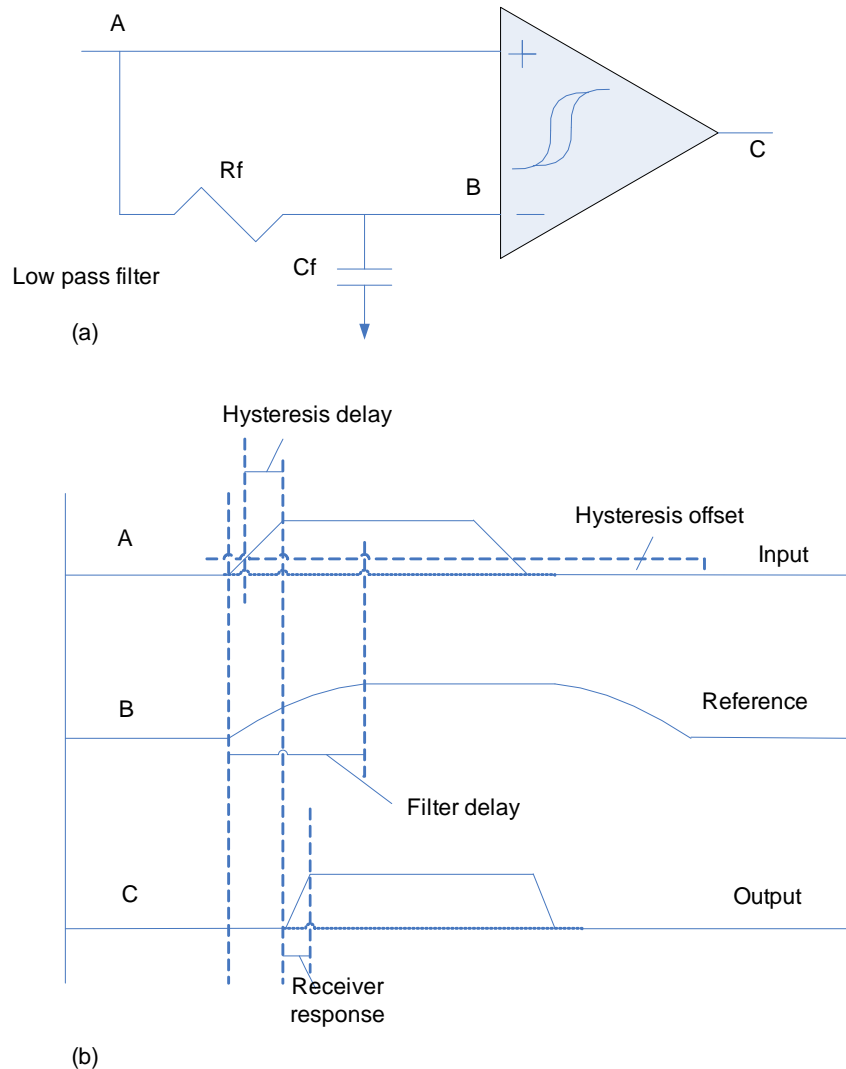
**Figure 11 Self-referenced Comparator and Response (See Note Below)**

When the comparator inputs are saturated the comparator gain is minimized and under certain PVT conditions (strong silicon, 125° C junction temperature, minimum VDDT), the comparator can fail to switch to the proper state, or not respond at all.

**Workaround:** Only one potential workaround has been identified so far. The failure mode of the AC-JTAG comparator is most pronounced by single edge transitions at low frequency as this creates the highest likelihood of the comparator inputs being saturated and switching incorrectly. More frequent transitions can result in proper switching of the comparator output.

The basic procedure is to initiate multiple edge transitions and then read the state of the RX input cell in question. However, due to the nature of the failure, the exact number would have to be determined experimentally for a given device.

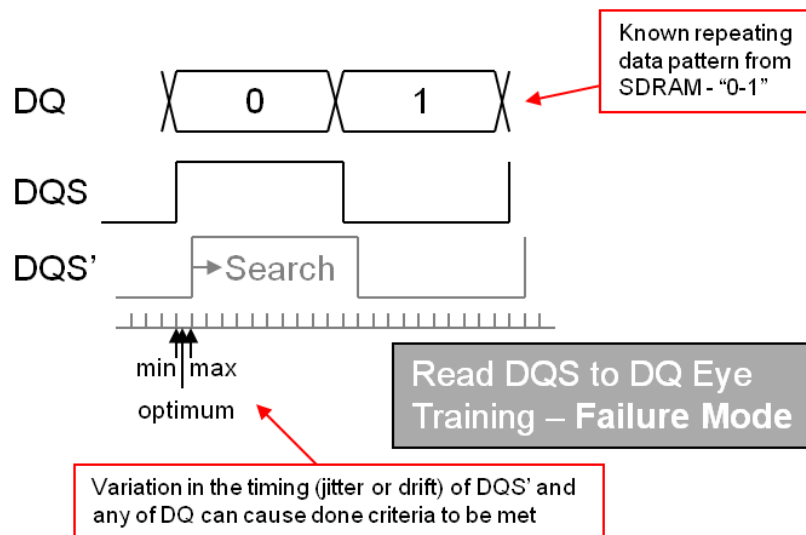
**Figure 14 Read DQS to DQ Eye Training - Failure Mode**

However, if too much jitter is present on the DQ or DQS signals, the search can converge to a false edge as shown in Figure 14.

This failure results in the data sampling location being placed in a very noisy transition region to the left of the DQ data eye. At this point corrupted data will then be read back to the DSP when a DDR3 read command is issued.

**Workaround 1:** The DDR3 PHY in the device has the ability to complete auto-leveling of the write leveling values and the read DQS gate training values separate from the read data eye training. Then a fixed value is used as the read data eye sample point. This solution is functional on standard DDR3 fly-by layouts and is referred to as Partial Automatic Leveling. It has been validated for robust operation at DDR3-1333 when connected to either a UDIMM or with a discrete SDRAM implementation.

This mode is enabled by setting bit 9 (0-indexed) of the DDR3\_CONFIG\_REG\_23 at address 0x02620460. The lower 8 bits (bits 7:0) may be written with a read data eye sample value or left at their default value of 0x34. The default value is recommended for use. After programming DDR3\_CONFIG\_REG\_23, proceed to enable auto-leveling. Please refer to the *DDR3 Initialization Application Report* (literature number [SPRABL2](#)) for details of the sequence of steps.

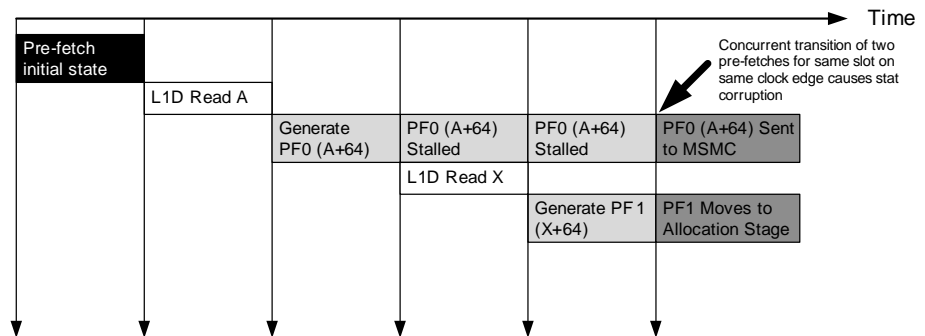
**Figure 17 Sequence Diagram**

- a. Must be Address Hit only, both 64 byte halves of entry [0] must not contain pre-fetch data.
- b. Entry [0] must be the 'oldest' entry, next entry to reallocate.
3. Data pre-fetcher re-fetch behavior is triggered which generates pre-fetch (PF0) to A+64.
4. PF0 stalls in XMC pipeline until step 7
5. L1D pre-fetchable data read to address X hits in candidate or pre-fetch buffer, triggering allocation of entry [0] to stream starting at X+64
6. A pre-fetch for address X+64 (PF1) is generated for entry [0] early half and followed in a subsequent cycle by X+128 (PF2).
  - a. Either PF1 or PF2 can map to the same buffer slot as PF0 (this example maps PF1)
7. PF0 transitions to the XMC output (to MSMC) on the exact same clock edge that PF1 is transitioning to the buffer allocation pipeline stage

8. Instead of PF0 being marked stale and thrown away when returned, both PF0 and PF1 are marked valid and outstanding.
9. This leads to two valid outstanding pre-fetches for the same data buffer slot which is an invalid state and can result in unexpected behavior for a subsequent pre-fetchable data access to address X+64.

Depending on whether the subsequent pre-fetchable data access to X+64 arrives before or after the second pre-fetch returns, the result can be a read exception and/or data corruption. The table below describes the different possible outcomes depending on the relative timing between following events:
