Errata

TMS320F2837xD Dual-Core Real-Time MCUs Silicon Errata (Silicon Revisions C, B, A, 0)

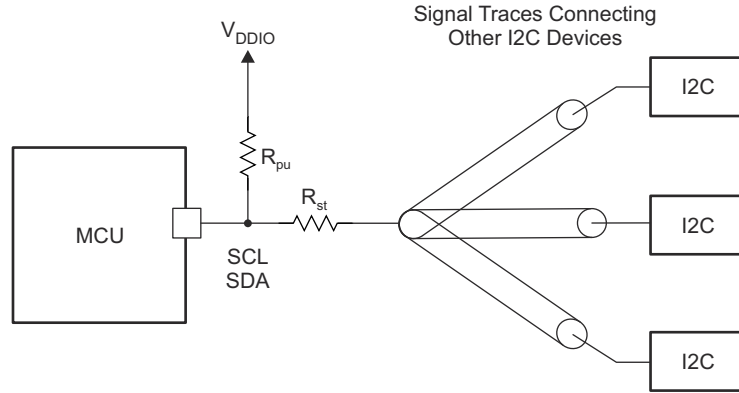
Figure 3-4. Placement of Series Termination Resistor and Pullup Resistor

The SDA and SCL outputs are implemented with push-pull 3-state output buffers rather than open-drain output buffers as required by I2C. While it is possible for the push-pull 3-state output buffers to behave as open-drain outputs, an internal timing skew issue causes the outputs to drive a logic-high for a duration of 0–5 ns before the outputs are disabled. The unexpected high-level pulse will only occur when the SCL or SDA outputs transition from a driven low state to a high-impedance state and there is sufficient internal timing skew on the respective I2C output.

This short high-level pulse injects energy in the I2C signals traces, which causes the I2C signals to sustain a period of ringing as a result of multiple transmission line reflections. This ringing should not cause an issue on the SDA signal because it only occurs at times when SDA is expected to be changing logic levels and the ringing will have time to damp before data is latched by the receiving device. The ringing may have enough amplitude to cross the SCL input buffer switching threshold several times during the first few nanoseconds of this ringing period, which may cause clock glitches. This ringing should not cause a problem if the amplitude is damped within the first 50 ns because I2C devices are required to filter their SCL inputs to remove clock glitches. Therefore, it is important to design the PCB signal traces to limit the duration of the ringing to less than 50 ns. One possible solution is to insert series termination resistors near the SCL and SDA terminals to attenuate transmission line reflections.

This issue may also cause the SDA output to be in contention with the slave SDA output for the duration of the unexpected high-level pulse when the slave begins its ACK cycle. This occurs because the slave may already be driving SDA low before the unexpected high-level pulse occurs. The glitch that occurs on SDA as a result of this short period of contention does not cause any I2C protocol issue but the peak current applies unwanted stress to both I2C devices and potentially increases power supply noise. Therefore, a series termination resistor located near the respective SDA terminal is required to limit the current during the short period of contention.

Insert series termination resistors on the SCL and SDA signals and locate them near the SCL and SDA terminals. The SCL and SDA pullup resistors should also be located near the SCL and SDA terminals. The placement of the series termination resistor and pullup resistor should be connected as shown in [Figure 3-4](#).

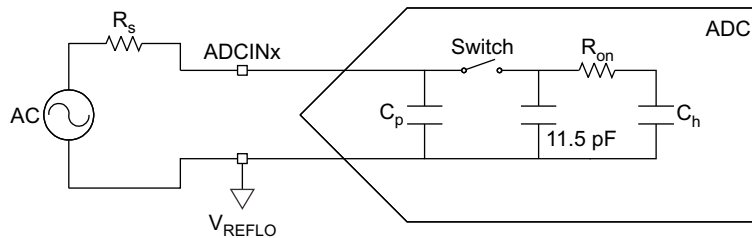
Figure 4-1. Single-Ended Input Model

Details The ADC input model should be used to select the sample-and-hold (S+H) duration for each ADC input. For the revisions affected, if the currently converting channel is an even-numbered channel and the previously converted channel was an odd-numbered channel (or vice versa), then the 12-bit input model will not accurately predict ADC input performance. Under these conditions, an additional capacitance should be added to the model. This capacitance has a value of 11.5 pF and should be placed between the S+H switch and R_{on} as shown in [Figure 4-1](#).

Workarounds For the revisions affected, when subsequent conversions switch between channel groups, the S+H duration should be chosen to account for the additional capacitance.
