## ABSTRACT

This document describes the known exceptions to the functional specifications (advisories) of the AM273x microcontroller. This document may also contain usage notes. Usage notes describe situations where the device's behavior may not match presumed or documented behavior. This may include behaviors that affect device performance or functional correctness.

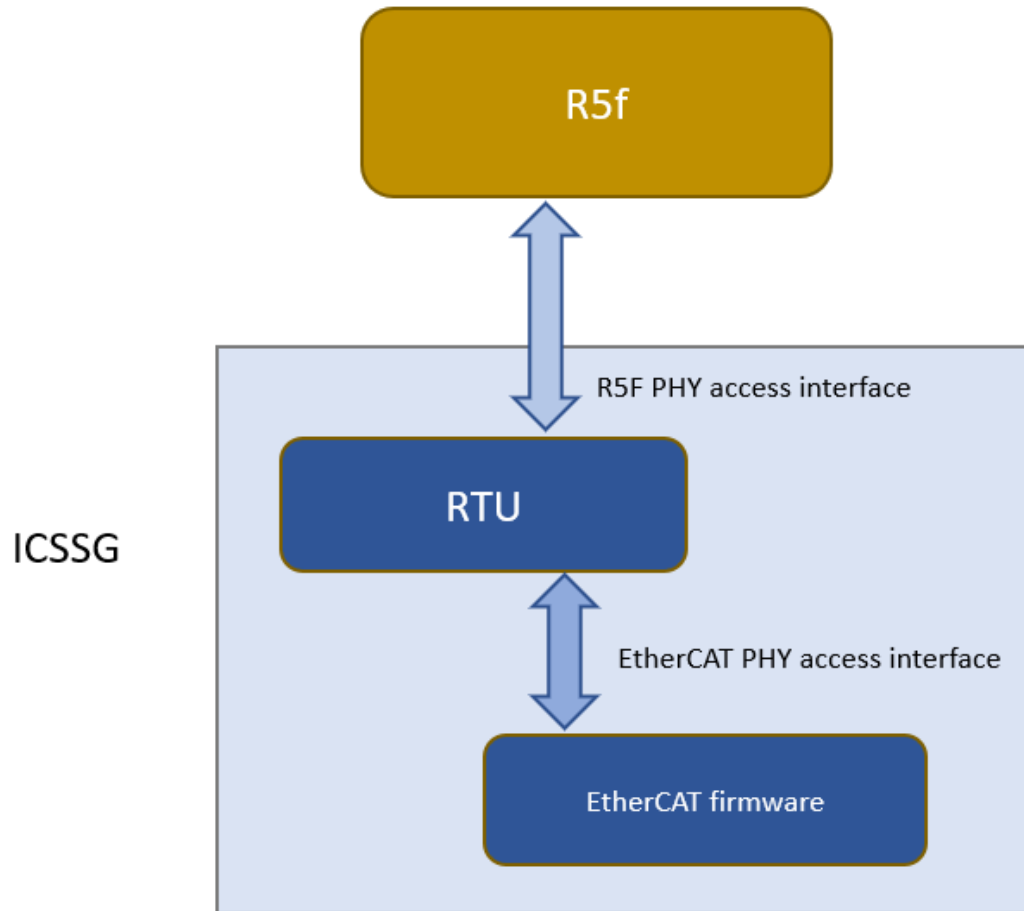
**Figure 2-1. MDIO Emulation via Manual Mode using PRU Core**

It is possible that the MDIO interface of all instances of CPSW and PRU-ICSS peripherals (if present) returns corrupt read data on MDIO reads (e.g. returning stale or previous data), or sends incorrect data on MDIO writes. It is also possible that the MDIO interface becomes unavailable until the next peripheral reset (either by LPSC reset or global device reset with reset isolation disabled in case of CPSW).

Possible system level manifestations of this issue could be (1) erroneous ethernet PHY link down status (2) inability to properly configure an ethernet PHY over MDIO (3) incorrect PHY detection (e.g. wrong address) (4) read or write timeouts when attempting to configure PHY over MDIO.

MDIO protocol can be emulated by reading and writing to the appropriate bits within the MDIO\_MANUAL\_IF\_REG register of the MDIO peripheral to directly manipulate the MDIO

clock and data pins. Refer to TRM for full details of manual mode register bits and their function.

In this case the device pin multiplexing should be configured to allow the IO to be controlled by the CPSW or PRU-ICSS peripherals (same as in normal intended operation), but the MDIO state machine must be disabled by ensuring MDIO\_CONTROL\_REG.ENABLE bit is 0 in the MDIO\_CONTROL\_REG and enable manual mode by setting MDIO\_POLL\_REG.MANUALMODE bit to 1.

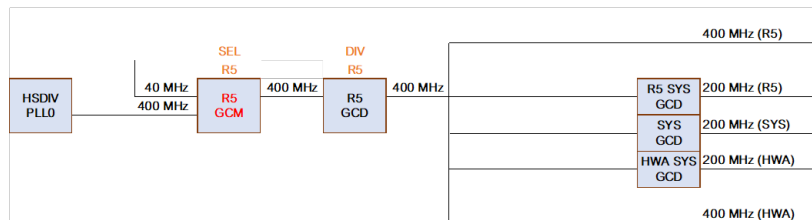
**Figure 2-2. PLL****Workaround(s):**

GCM circuit [highlighted] is susceptible to glitch when switching the clock source from Crystal to the PLL Clock, causing the phase misalignment between SYS clocks resulting in random behaviors like aborts or hangs or access failures. Reference below for HSDIV0 feeding clock to R5F and SYS Clocks.

- 1: Use external WDT to reset in case of hang scenarios.
- 2: Use staggered PLL programming sequence [Step 1 to Step 5] to switch from 40MHz-200MHz – 400MHz in SBL. Application where R5F Running at 400MHz (Core PLL HSDIV0CLKOUT0 output is 400MHz)
