AM1810 ARM Microprocessor Silicon Revisions 2.3, 2.1 and 2.0

Silicon Errata

Literature Number: SPRZ339H
November 2010–Revised September 2014

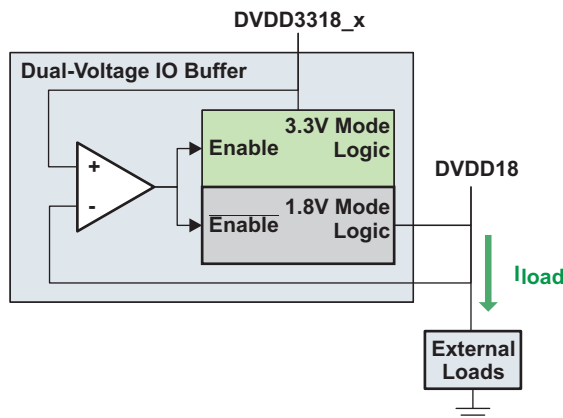
Figure 6. Error State of the IO buffer during Zone G

If DVDD18 continues to rise as DVDD3318_x ramps, the comparator never sees enough difference between the two supplies to switch to 3.3V mode.
