AM1802 ARM Microprocessor Silicon Revisions 2.3, 2.1 and 2.0

Silicon Errata

Literature Number: SPRZ340H
November 2010–Revised September 2014

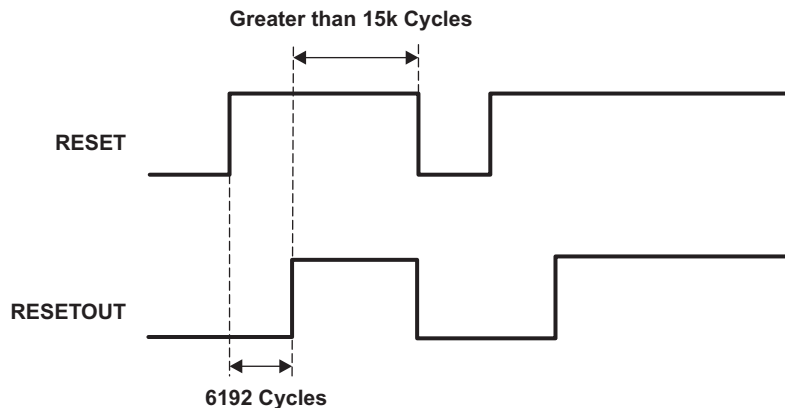
Figure 8. First POR Reset Timing

Note that in order to recover from this fail state with a secondary reset, the Boot System must be allowed to execute up to the point where it has fetched a known instruction from memory. The approximate count of 15k clock cycles is sufficient.

The 15k clock cycle count does not include the 6192 clock cycles required to complete a device POR reset (see [Figure 8](#)). With a 24MHz crystal, the first RESET signal must be asserted high for at least 883us (or approximately 1ms).

Modify the target board so that the affected device is given a secondary reset on power-up as shown in [Figure 8](#). Two example methods are described in the sections that follow.
