# **TMS320C6670**

*Multicore Fixed and Floating-Point System-on-Chip*

## **Silicon Errata**

Literature Number: SPRZ332F  
May 2014

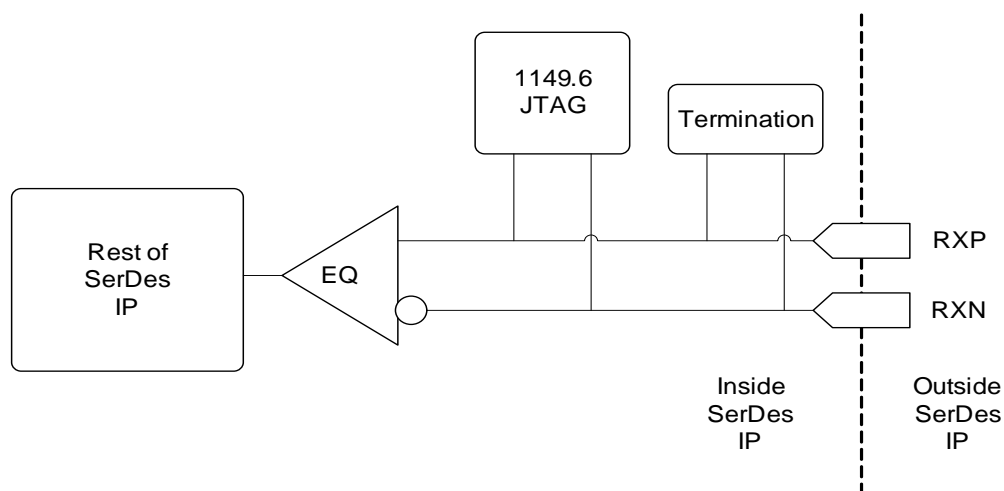
**Figure 10** Simplified SerDes receiver block diagram depicting relative placement of major receiver components

The SerDes receivers as shown in [Figure 10](#) for AIF2, SRIO, PCIe, SGMII and Hyperlink are all designed to be AC coupled to their associated transmitters. For these AC-coupled SerDes receivers the IEEE 1149.6 scan-chain provides edge-sensitive sensing.

A problem has been identified in some cases where the AC-JTAG (IEEE 1149.6, edge-sensitive) input cells on receivers do not reliably respond to input edge transitions from an associated transmitter. Because of this failure, the 1149.6 scan-chain users can receive faulty signal levels transitions or no transitions at all.

IEEE 1149.1, level-sensitive, input cells show no issue and normal operation of the SerDes receivers is also unaffected by this problem.

The reason for the issue is due to the original AC-JTAG input cell performance being overly sensitive to rise/fall times of the signals interfacing to it and input transition frequency.

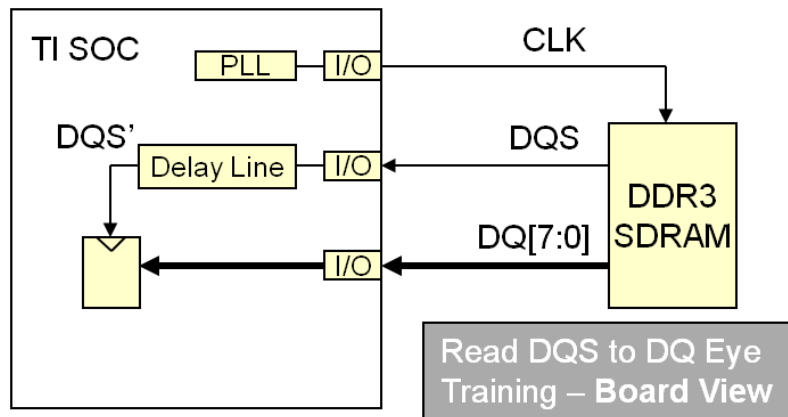
**Figure 12 Read DQS to DQ Eye Training - Board View**

The intended purpose of the Read Data Eye Training feature is to align the DQS sampling transitions in the middle of the DQ data eye within individual byte lanes of the DDR3 memory interface. As seen in [Figure 12](#), the DQS signal can be delayed relative to the DQ signal within the DDR3 PHY.

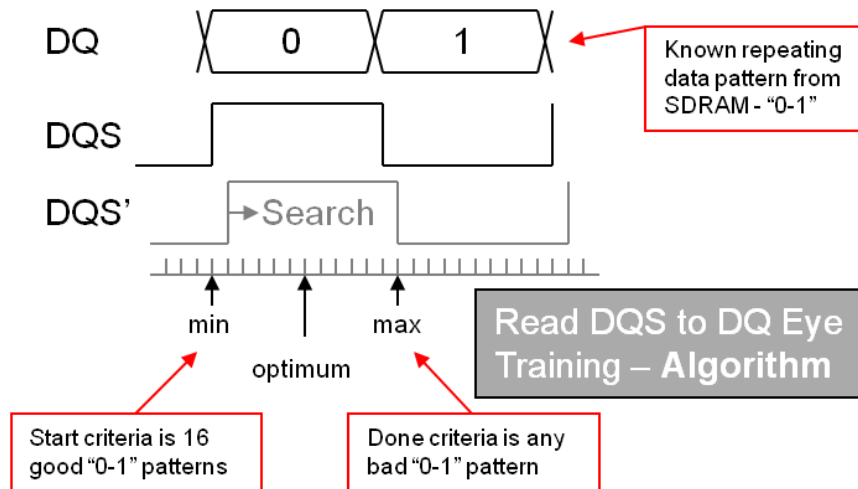
**Figure 13 Read DQS to DQ Eye Training - Algorithm**

As shown in Figure 13, the Read Data Eye Training algorithm should correctly detect the extents of the DQ data eye. The SDRAM is put into a DQS-to-DQ eye training mode and read back an alternating 0, 1 pattern.

The DDR3 PHY uses this pattern to detect good or bad data being sampled by the DQS transitions. The DDR3 PHY searches by delaying DQS relative to DQ until these constraints are found.

However, if too much jitter is present on the DQ or DQS signals, the search can converge to a false edge as shown in Figure 14.

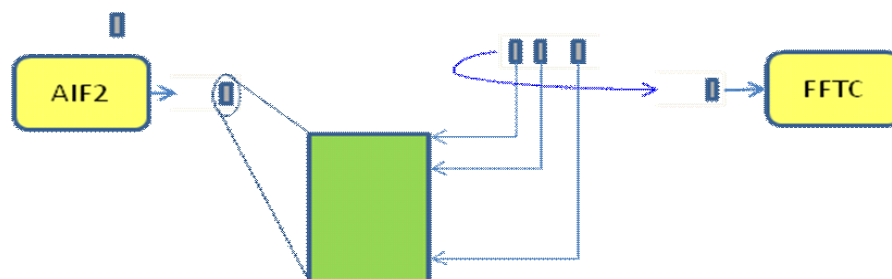
**Figure 18** Symbol Processing on Ingress

[Figure 18](#) shows detailed description on Ingress:

Pre-configure a set of descriptors that point to the correct offset in jumbo packet for each symbol, store the descriptors in the FFTC Tx FDQ or an array. AT event trigger the EDMA to pop and push the descriptors from FFTC Tx FDQ to FFTC Tx Q. EDMA needs to pop the descriptor from the Tx FDQ and push to the FFTC Tx Q. If the AIF2 output packet PS words are needed, then it will need to be copied by EDMA before pushing the descriptor to the FFTC Tx Q. If using AT event to trigger EDMA, after pushing the descriptor, EDMA needs to clear the CP\_INTC to prepare the subsequent AT event trigger. As there is no real need for the AIF2 output queue itself, AIF2 Rx Q can be set to be the same queue as the Rx FD, Therefore no need to recycle the AIF2 output descriptor.

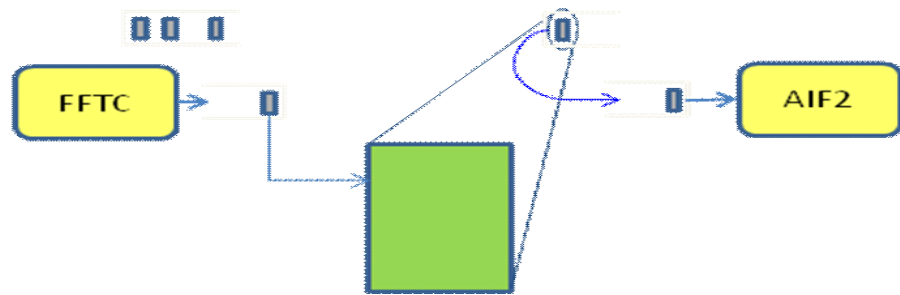
**Figure 19 Symbol Processing on Egress**

Detailed description on Egress is shown in [Figure 19](#).

Assuming FFTC generates the packet, FFTC Rx FDQ needs to be prepared such that the descriptors point to the right position of the AIF2 jumbo packet for each symbol. Once every jumbo packet period, the jumbo packet descriptor can be pushed to AIF2 Tx queue. This can potentially be done by CPU as it is likely that it could be aligned with LTE DL symbol processing. As there is no real need for the FFT output descriptor itself, FFTC Rx Q can be set to be the same queue as the Rx FDQ, Therefore no need to recycle the FFTC output descriptor.
