Errata
MSP430F5631 Microcontroller

ABSTRACT

This document describes the known exceptions to the functional specifications (advisories).

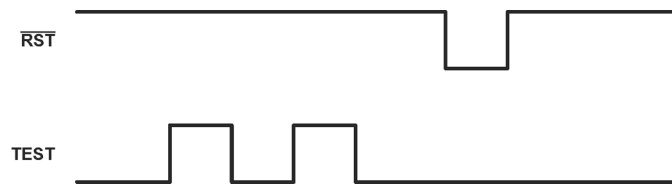
- Toggle the TEST pin twice when nRST is high and after 50us pull nRST low.

Note: This toggling of TEST pins is not subject to timing constraints. The appropriate level transitions on TEST pin, followed by a RST pulse after 50us, are sufficient to trigger an exit from BSL mode.
