RM42x Microcontroller

Silicon Revision B

Silicon Errata

Literature Number: SPNZ227A
March 2015–Revised May 2015

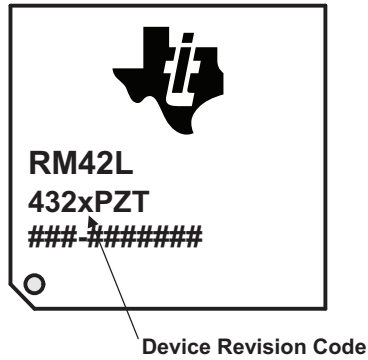
Figure 1. Part Marking

Figure 1 provides an example of the RM42Lx device markings. The device revision can be determined by the symbols marked on the top of the device.
